APPENDIX B

EAST PIONEER MOUNTAIN WETLAND/CHANNEL RESTORATION AND MITIGATION PLAN VERSION 2

***Yellowstone Mountain Club
Big Sky, Montana***

Project No: 140347.08A

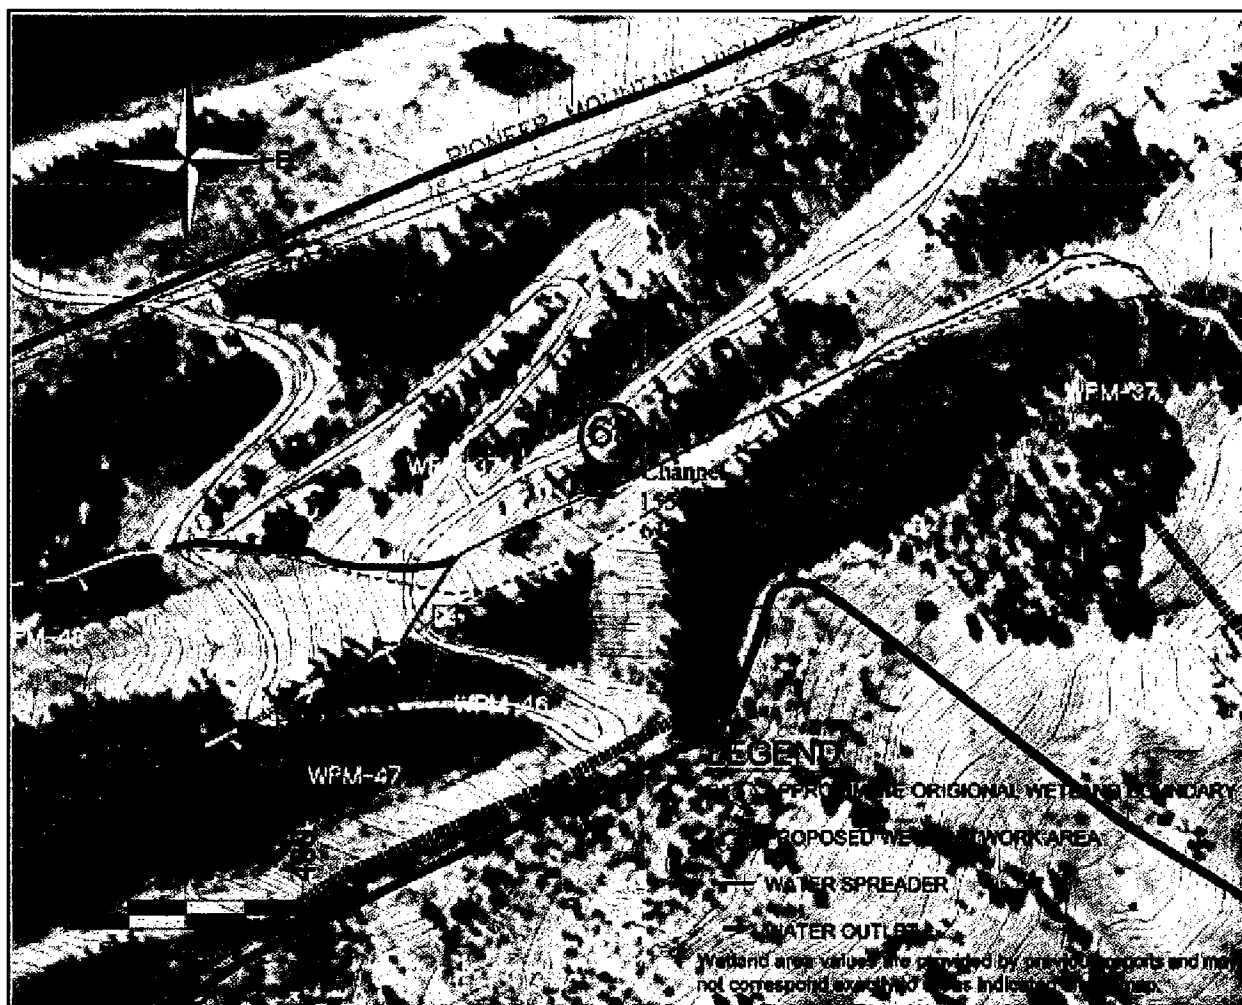
Pioneer Mountain Restoration Site

LWC Site No: 68
 Culvert No: 37,46
 Wetland No. Above: WPM-46
 Wetland No. Below: WPM-37
 Watershed: Ebitda
 Ski Run: Ebitda / Quarterback Sneak
 Quadrant: G/H-7
 Zone: F
 Area of Disturbance: 6171 square feet (0.14 acre)
 Restoration Plan: At the upper end of this site, Ebitda run intersects Wetland WPM-46 and Culvert 46 connects the two portions of WPM-46. At the lower end of this site, Quarterback Sneak run intersects WPM-37 and Culvert 37 connects the two portions of WPM-37. Due to the size and complexity of this site, a detailed channel design will be completed that also addresses stormwater concerns. The existing culvert will be removed. A high energy channel will be constructed along the south side of Quarterback Sneak run connecting the upper and lower portions of WPM-46 as well as a branch connecting WPM-45. These channels will have grade control structures and revegetation.

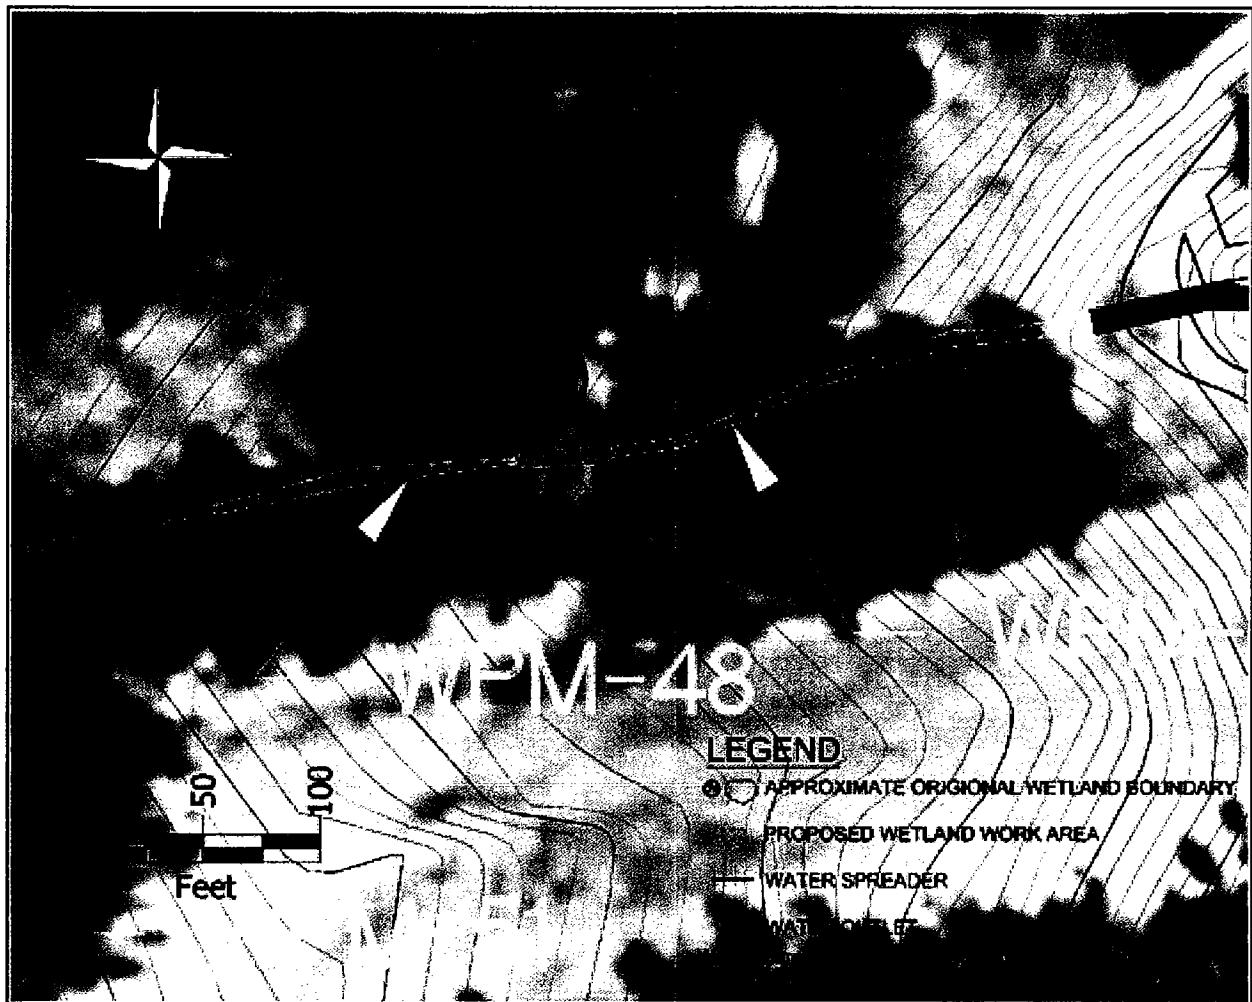
Pioneer Mountain Restoration Site

LWC Site No: 71
Culvert No: None
Wetland No. Above: WPM-48
Wetland No. Below: WPM-45
Watershed: Ebitda
Ski Run: None
Quadrant: F-7
Zone: F
Area of Disturbance: 114 square feet (0.002 acre)
Restoration Plan: Restoration will include reconstructing a small low energy channel between WPM-48 and WPM-45.
